# CAPA BI Bundle Inspection

The station CAPA BI

inspects folding boxes that have been combined into a bundle. Inspection of individual folding boxes is also possible. For bundle inspection, area scan cameras of the **SIGNUM 2DC**

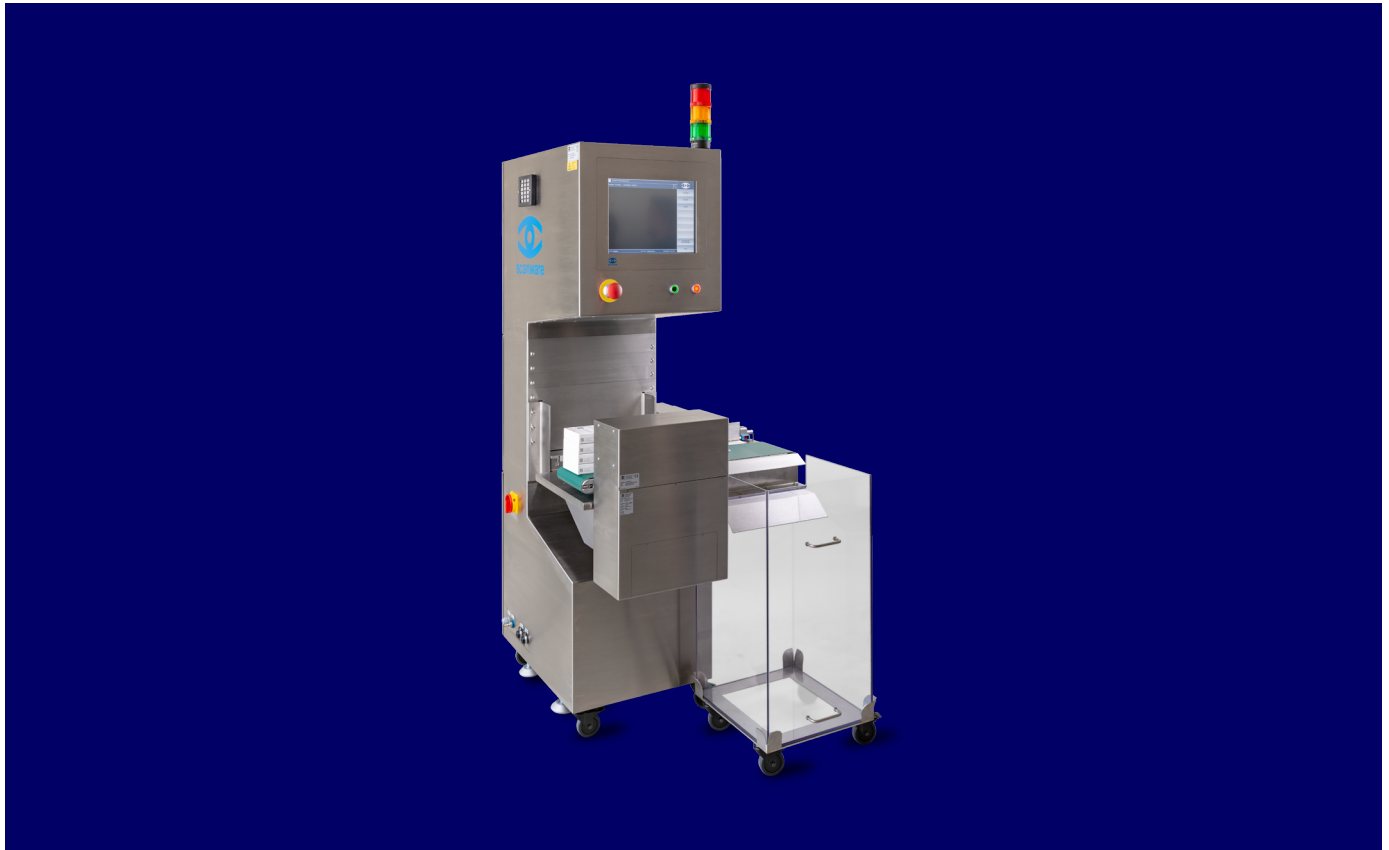
system are used to check 1D and 2D codes for readability and bundle completeness. Aggregation and serialisation of the data can be implemented using **IMPERA**

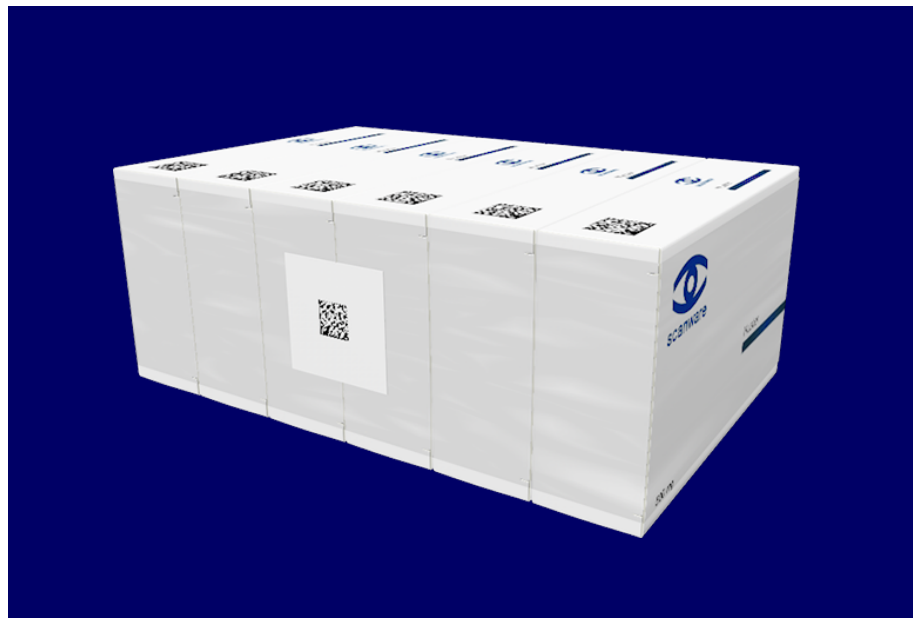
- Criteria: Readability of 1D and 2D codes e.g. Code 128 and DataMatrix as well as completeness of bundles
- Different inspection positions possible (top, front and back)
- Equipped with a conveyor band (200 mm width)
- Where the camera is installed above, its height can be adjusted mechanically. This enables adjusting the image acquisition area to the bundle size.

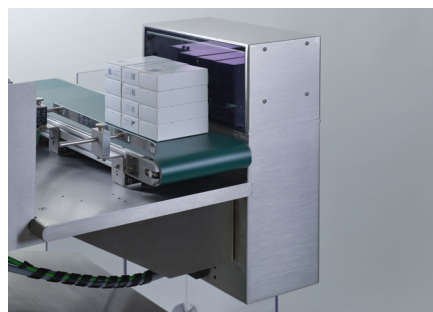
Close-up of camera

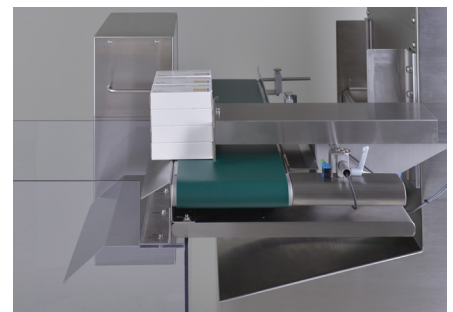
Pneumatic ejection system

A pneumatic ejection system allows the bundle to be ejected when a fault is detected. A guide rail has been installed to guarantee that the bundles are guided in the correct position. This is also used for adjusting the format without tools (adjustable according to the bundle size).
